**SCOB \* Q46 86-108099/17 \* EP-178-842-A**  
**Repair system for power cable utility poles - includes excavating to allow fitting of multi-part sleeve around pole and filling of gap with non-shrinking hardenable cement**

⑰ **Repairing utility poles.**

The invention relates to the in-situ repairing of utility poles.

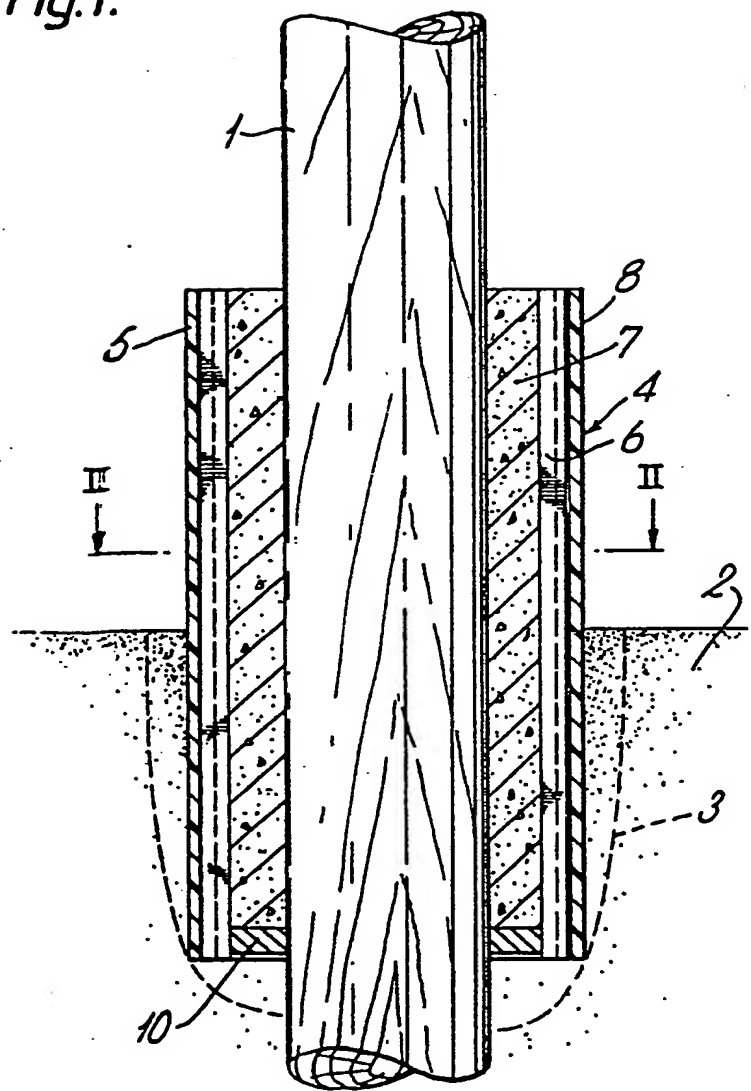
Fig.1.

Figure 1 is a diagrammatic section through a utility pole about where it leaves the ground;

With reference to the drawings, a utility pole 1 may be a cylindrical wooden pole and has previously been set in the ground 2 by the digging or boring of a hole. If damage or attack has occurred to the pole at or below ground level (which is the most common position for such damage, corrosion or rotting) it is repaired by the excavation around the pole of a small void (dotted lines 3) and the placing around it of a multipart sleeved construction 4. As seen in Figure 2 in the present embodiment this construction has two equal and identical halves 5 which can be clipped together by manual distortion of the sleeves, so that flange 6 is trapped by claw 8, each extending along respective edges of the half-sleeves. An alternative method of clipping the halves together is shown in Figure 3, with a U-strip 9 passed over the out-turned flanges 6'. At the bottom and indeed elsewhere on the sleeve may be spacers for maintaining a regular and desired spacing between the inner circumference of the sleeve parts and the pole. The appropriate spacing will depend on the dimensions of the pole and its expected loading. As seen in Figure 1, a ring 10 closed around the pole may act simultaneously as spacer and as a seal for the bottom of the sleeve.

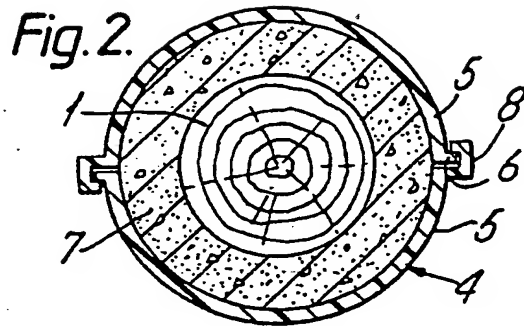
Figure 2 is a section on the line plane 2.2 of Figure 1,
